DEPARTMENT OF TRANSPORTATION

Contract #: 04-0120F4Cty: SF/ALA Rte: 80 PM: 13.2/13.9File #: 99.28**WELDING INSPECTION REPORT****Resident Engineer:**Pursell, Gary**Address:** 333 Burma Road**City:** Oakland, CA 94607**Report No:** WIR-016529**Date Inspected:** 30-Aug-2010**Project Name:** SAS Superstructure**OSM Arrival Time:** 700**Prime Contractor:** American Bridge/Fluor Enterprises, a JV**OSM Departure Time:** 1900**Contractor:** Zhenhua Port Machinery Company, Ltd (ZPMC)**Location:** Shanghai, China

WELDING INSPECTION REPORT

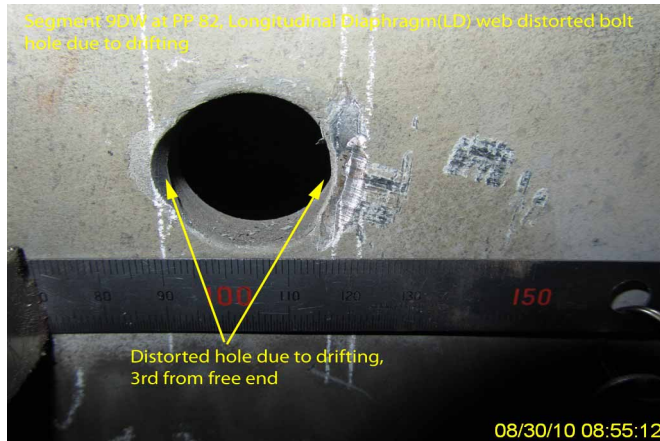
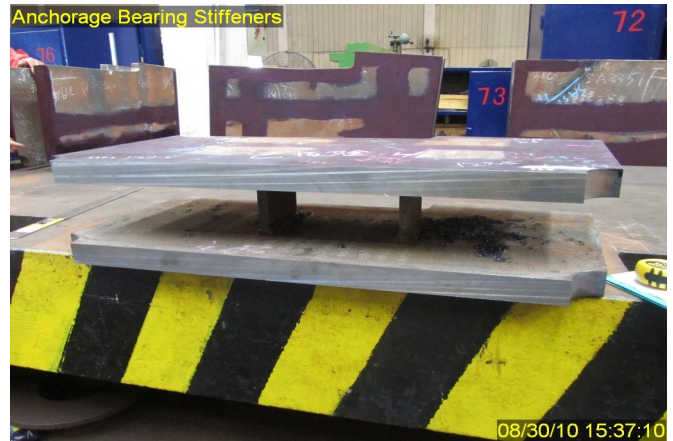
This Quality Assurance (QA) Inspector wrote an Incident Report for distorted bolt hole due to drifting action at Longitudinal Diaphragm web at PP 82 for Segment 9DW at work point W4. Please reference the Incident Report 04-0120F4_TL-15_B278_08-30-2010_LD_Web_distorted bolt hole_due to drifting_9DW at PP 82_at W4 dated August 30, 2010 for further details.

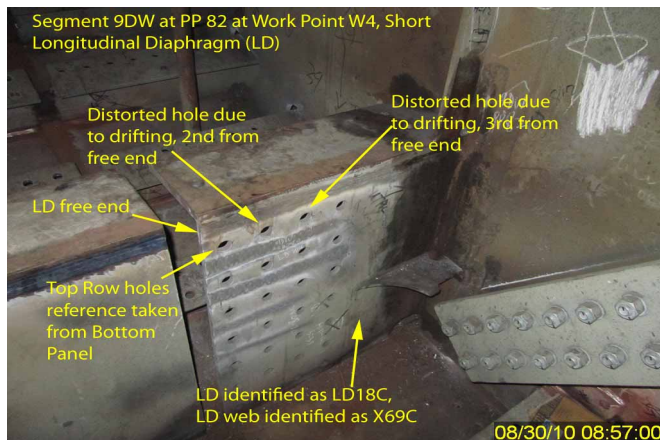
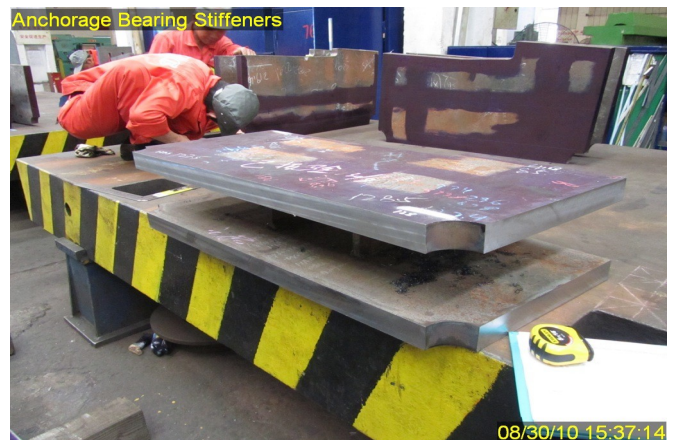
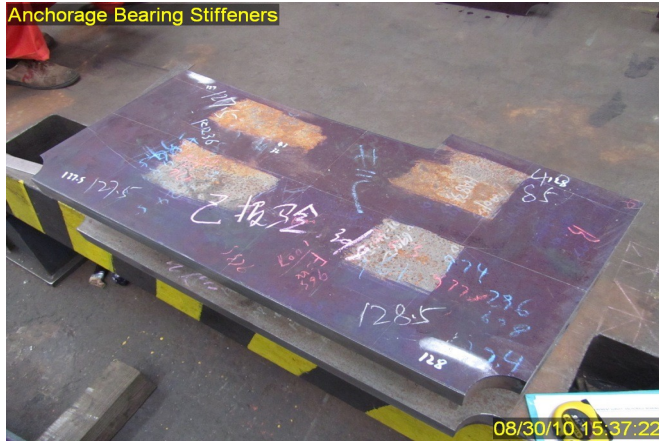
This QA Inspector performed Dimension Control Inspection to check and measure the Anchorage Bearing Stiffeners at machine shop # 1. The following below mentioned dimensions was inspected.

Anchoring Bearing Stiffeners, surface condition meeting mill to bear condition at MTB1, MTB2 and MTB3 locations.
